The collapse of 1284 at Beauvais Cathedral

S. Murray

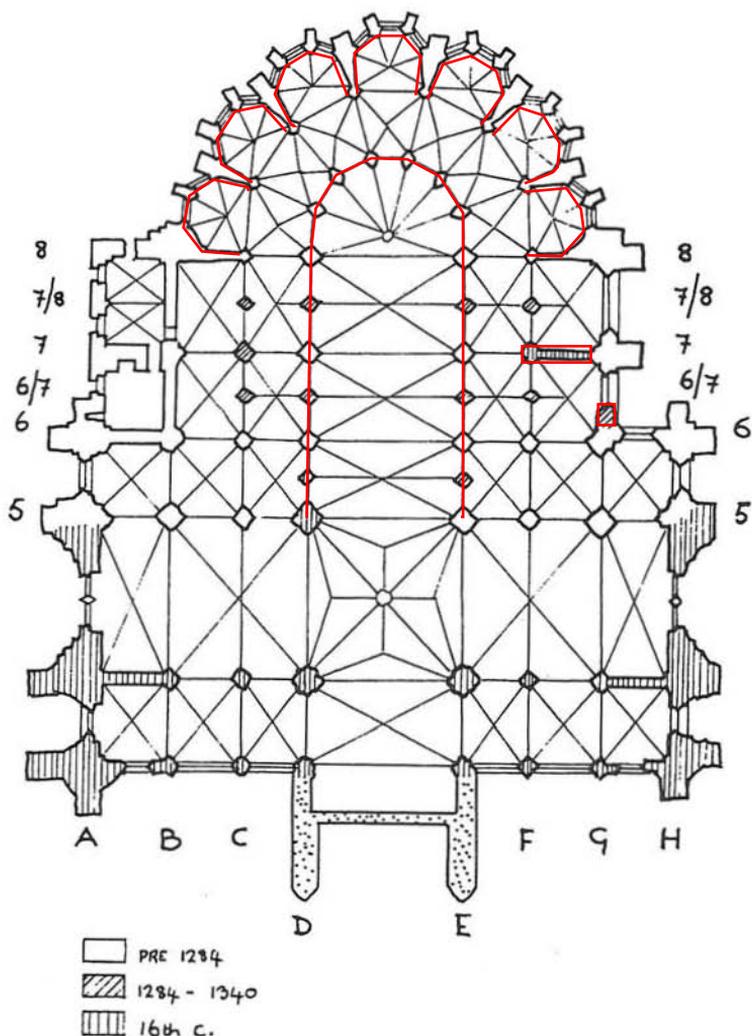
FIGURE 1. Plan of Beauvais Cathedral, showing repairs after the collapse.

Firstly, it is evident from the plan that this is the only bay where the lateral thrust of the high vaults was not countered by the heavier masonry at the east and western terminations of the choir (Fig. 1). It is of interest to find an analogous situation in the very well-documented building history of the cathedral of Troyes, where it was necessary in the 1360's and again in 1402 to consolidate the lateral buttressing at a point corresponding to this.¹⁸ It is, of course, inherent in this kind of plan that whereas the blocks of masonry dividing the radiating chapels provide a kind of internal buttress, this kind of support is absent in the straight bays.

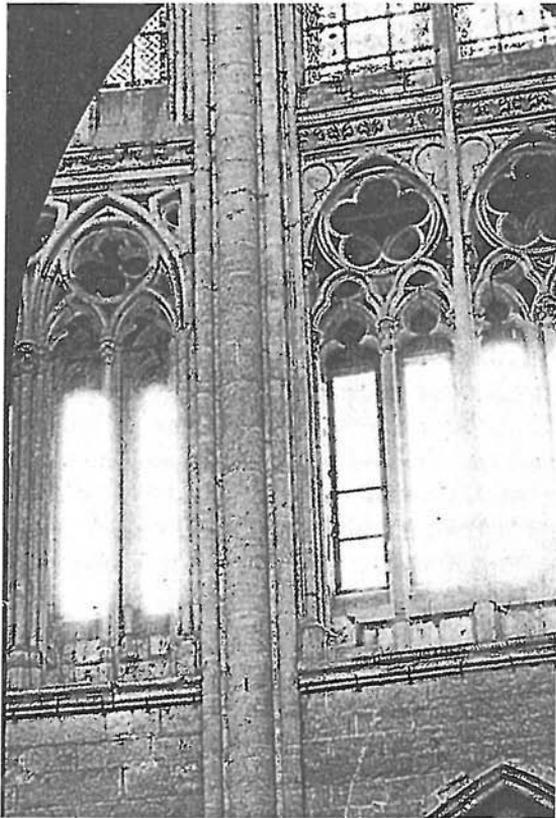
FIGURE 2. *Detail of the triforium at bay 8 on the north side, showing the transition from pre-collapse to post-collapse tracery.*

A survey of the forms of the tracery, capitals and bases reveals quite clearly that everything from the sill of the triforium of the central vessel, up to the high vaults was rebuilt in the straight bays of the choir (Fig. 2). At the same time the additional piers were inserted in the main arcade, to create sexpartite vaults in the central vessel. While it is impossible to distinguish between new and re-used masonry in the vaults, it is noticeable that three of the present clerestory windows are different from the others in the tracery patterns used, raising the possibility that they might constitute units pieced together out of elements surviving the collapse (Figs. 3 and 4).¹⁰

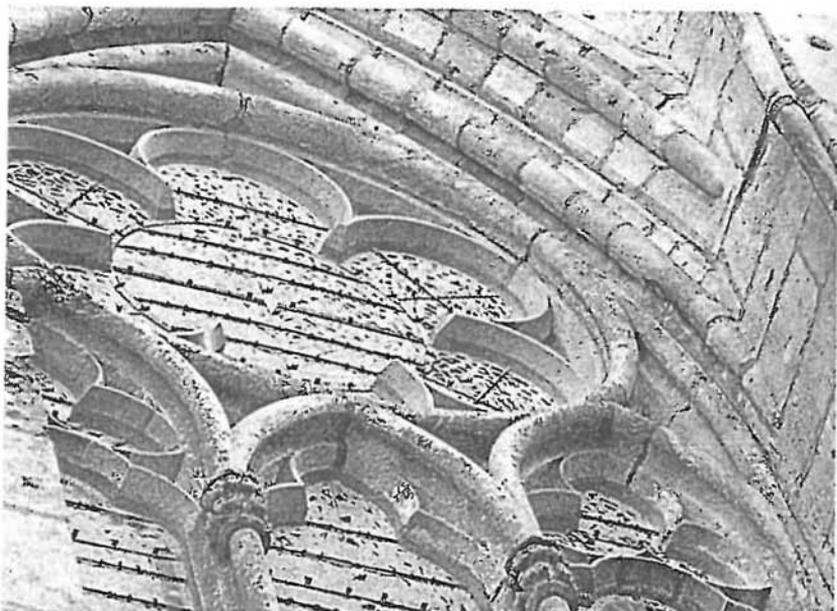
FIGURE 3. *Detail of re-used tracery in clerestory window.*

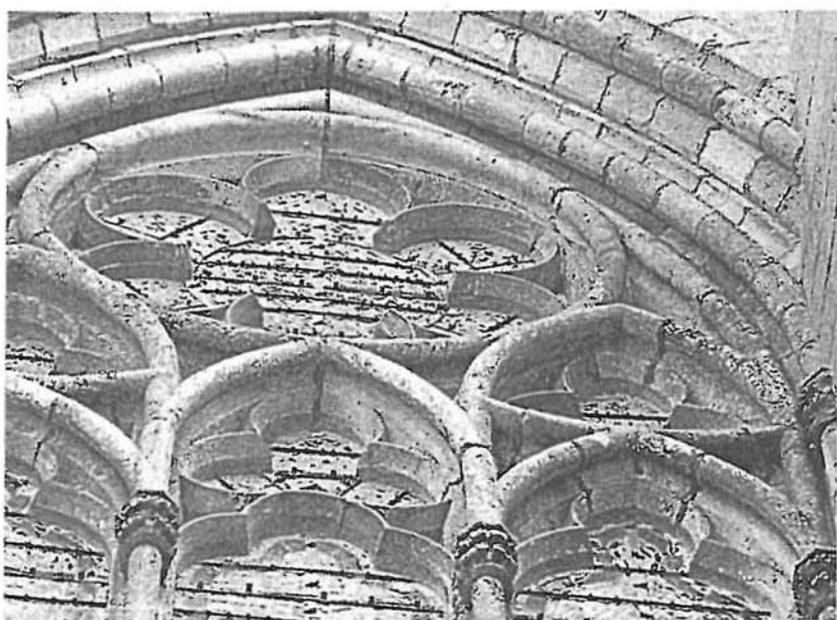
FIGURE 4. *Detail of tracery made in the campaigns of repair after the collapse.*

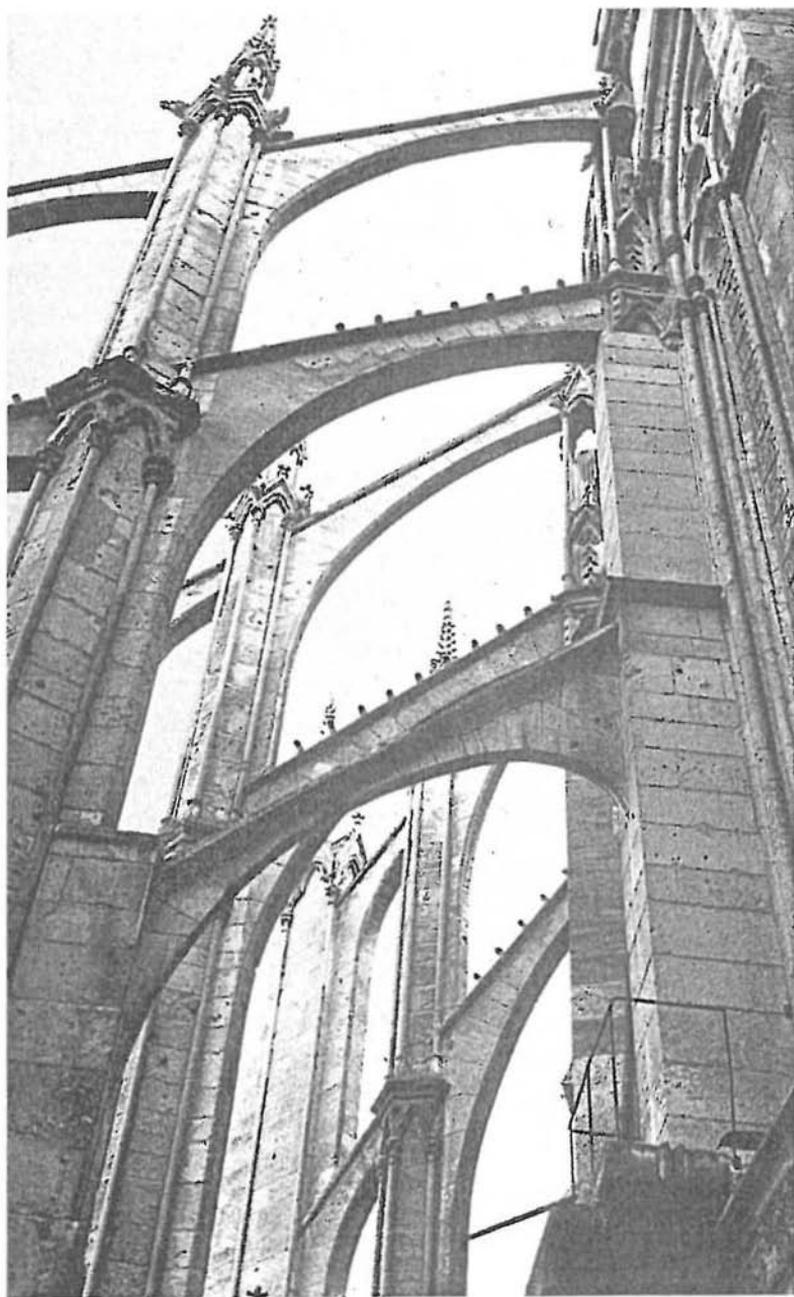
The upper hemicycle (including the vault) remained intact, as did the hemicycle flying buttress system (Fig. 5). Only the exteriors of the upper hemicycle piers were rebuilt, replacing an arrangement which Viollet-le-Duc reconstructed (on paper) as openwork tabernacles, with fully detached shafts.¹¹ The fact that this feature of the otherwise intact hemicycle was rebuilt, presumably after the 1284 collapse (although the masonry is anonymous in terms of stylistic identifying forms) led Viollet-le-Duc to his theory that it was precisely this element in the design of the upper superstructure which caused the collapse. His account of the differential settlement of the coursed masonry, as opposed to the detached shafts has become a "classic" interpretation of the potential mechanics of collapse, and it has secured many adherents.¹² If we follow Viollet-le-Duc's thesis, then we must view the source of the weakness in the design of the upper superstructure as essentially a longitudinal one, running on the east-west axis of the building. For Viollet-le-Duc, moreover, this was a faulty detail in an otherwise well-conceived structure, the "Parthenon of French Gothic".¹³

FIGURE 5. *Exterior of the hemicycle at clerestory level.*

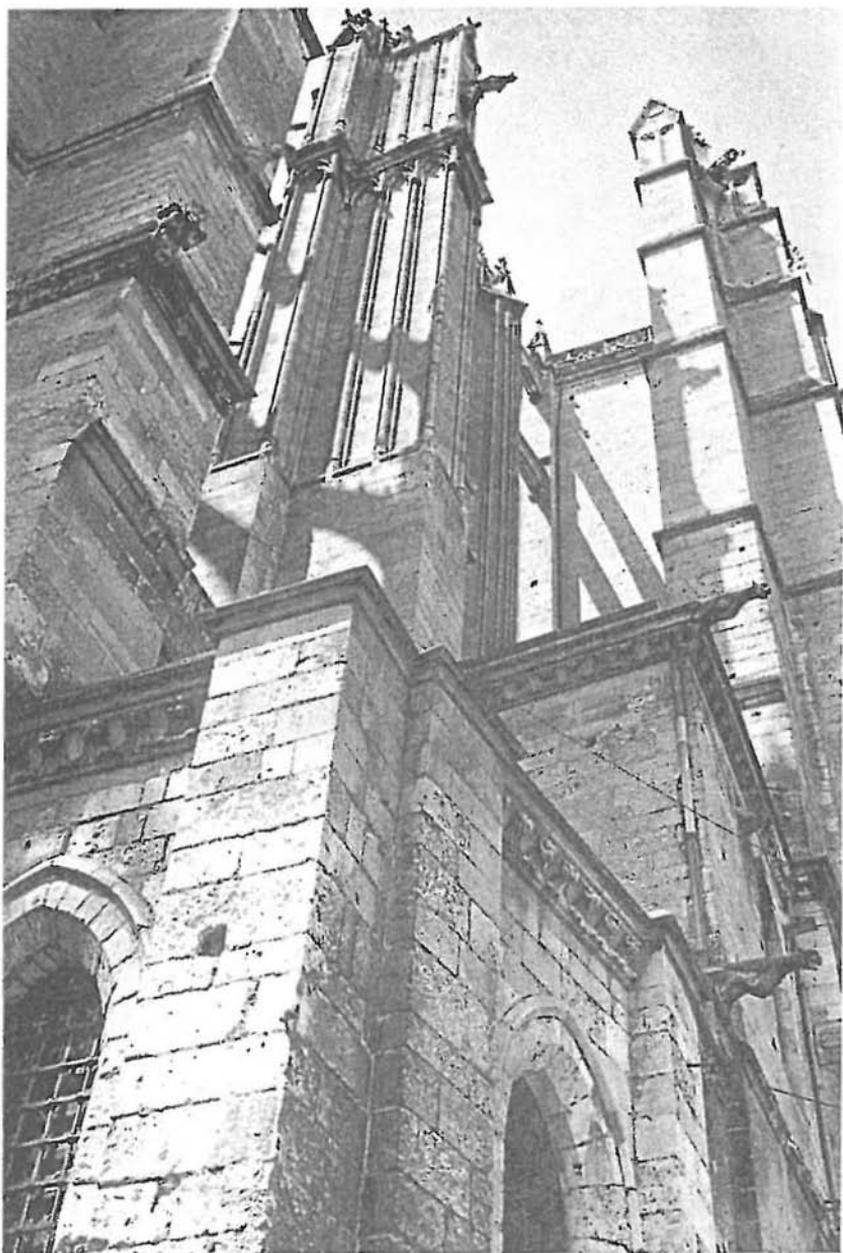
Following these criteria we may determine that two of the main outer flying buttress uprights have been rebuilt on each side (in bays 6 and 7) and that in the straight bays of the choir only one of the intermediary uprights on each side has been rebuilt, namely at bay 7 (Figs. 7, 8, 9 and 10). The intermediary uprights at bay 6 show no sign of having been rebuilt, and employ *en délit* shafts and bases of the low variety (Fig. 9).

FIGURE 7. *Outer upright of flying buttress, bay 7, north side.*

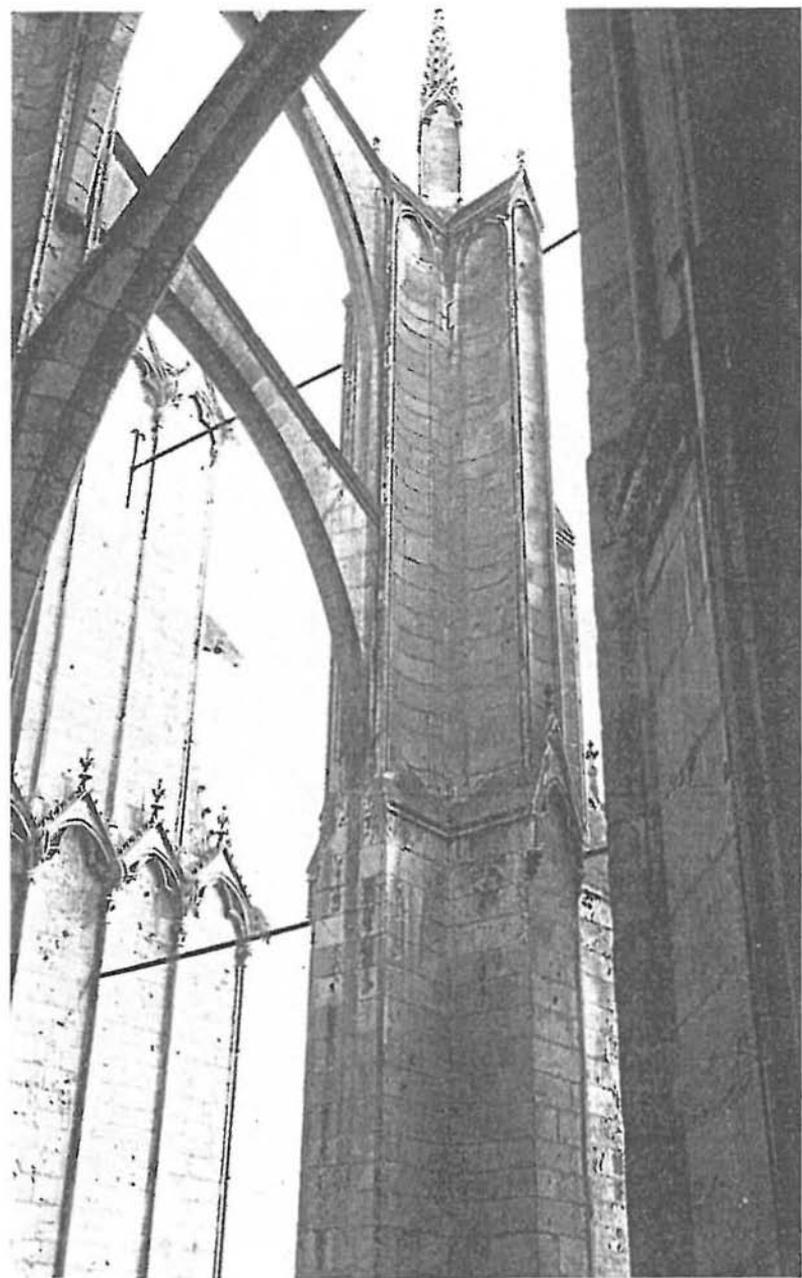
FIGURE 8. *Outer upright of flying buttress, bay 7, south side.*

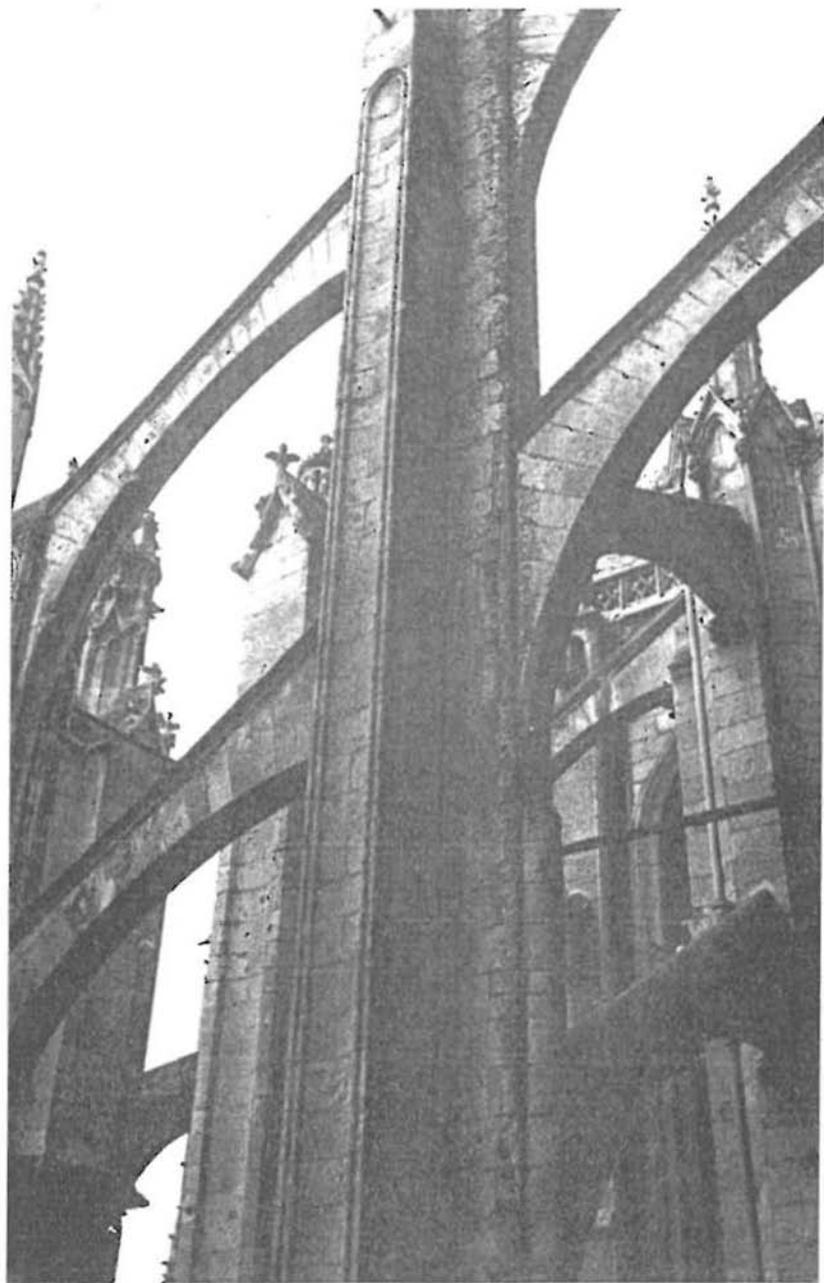
FIGURE 9. *Intermediary flying buttress upright, bay 7, south side.*

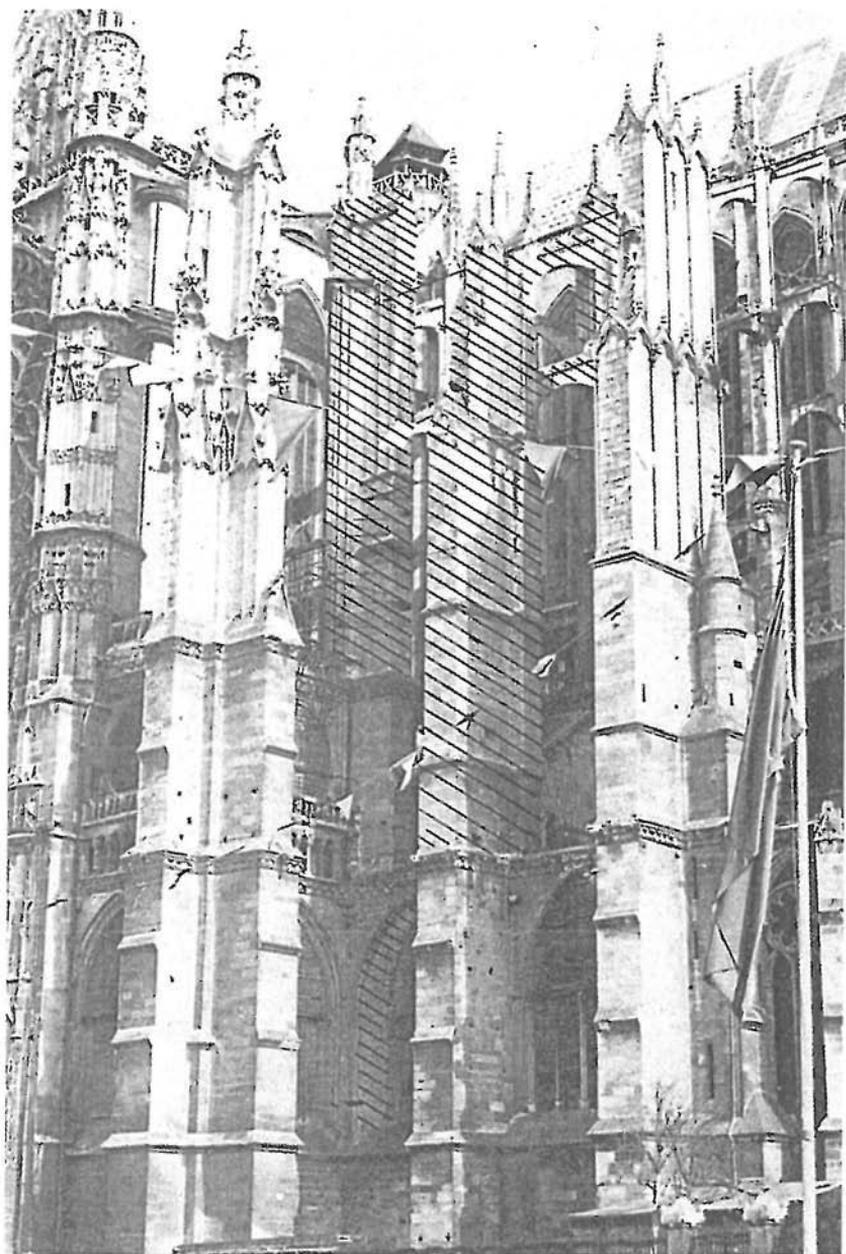
FIGURE 10. *General view of the south side of the choir. Cross-hatching indicates parts rebuilt after the 1284 collapse.*

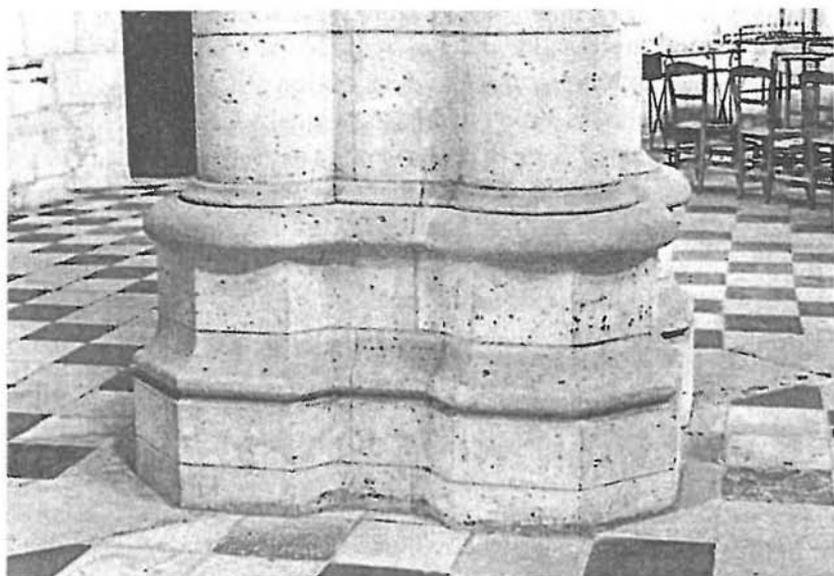
FIGURE 11. *Pier C 7 in the north choir aisle.*

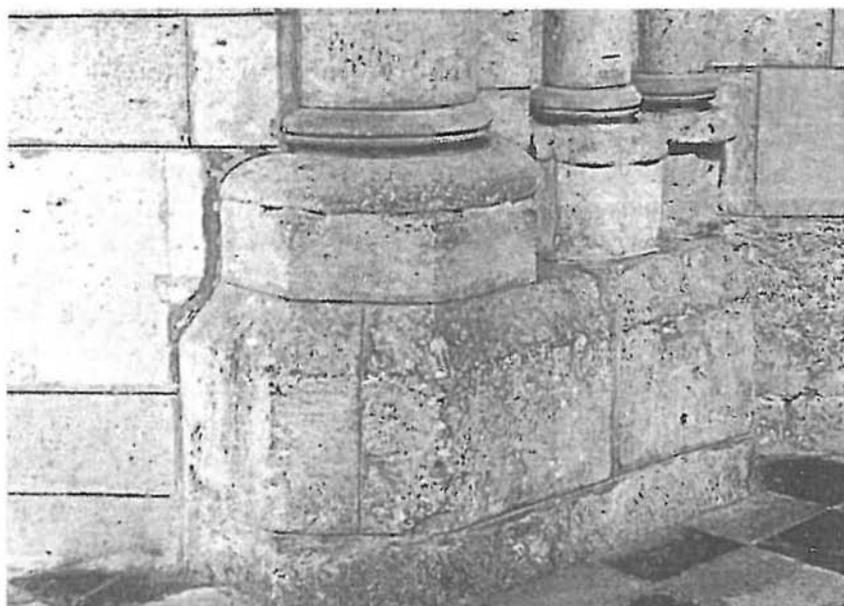
FIGURE 12. *Pier B 7 in the north choir aisle.*

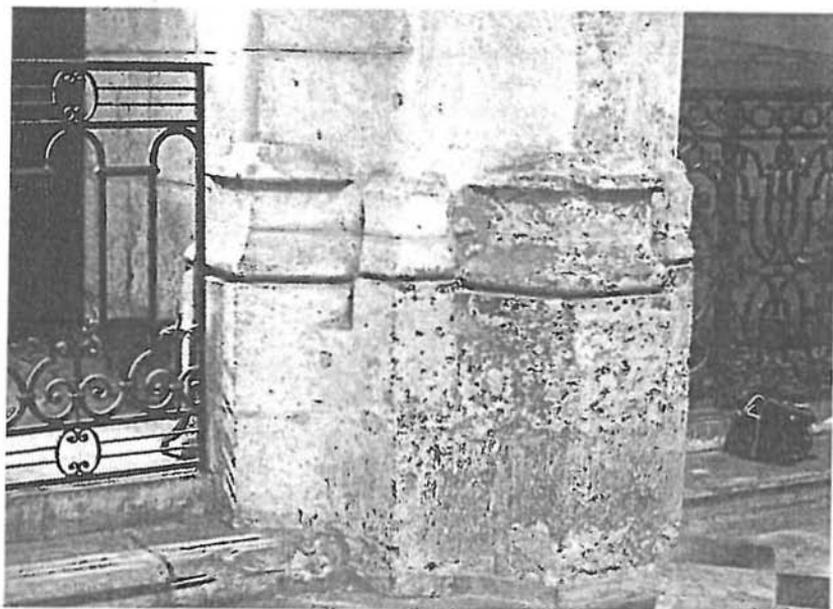
FIGURE 13. *Pier F 7 in the south choir aisle.*

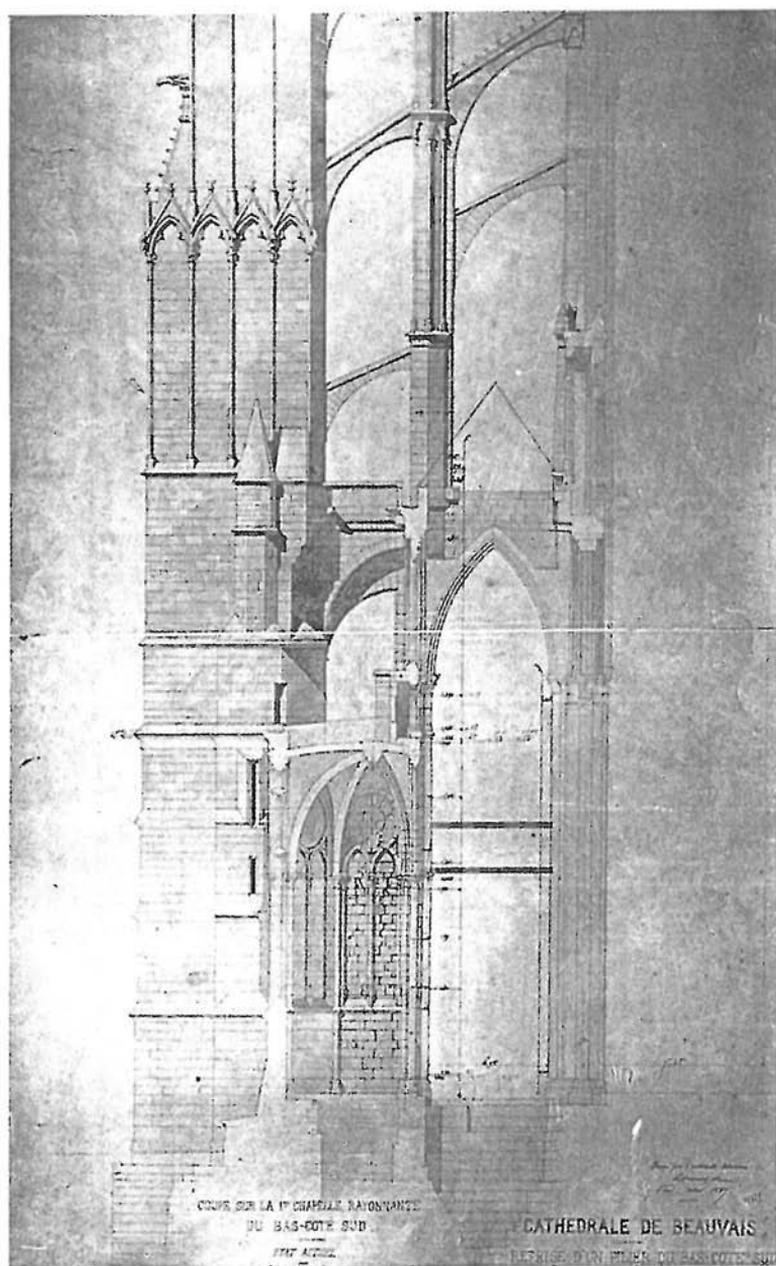
FIGURE 14. *Drawing made for the restoration of pier F 8 by the architect Sauvageot in 1897 (MH. 201374).*

and drawings²³ made at this time reveal precisely how they would have failed, had they been left unattended (Fig. 14). The plumb line indicated in our restoration drawing reveals that the inward buckling of the piers in the chapel mouths on either side of the choir at bay 8 occurred at the height of the springing of the vaults of the first radiating chapels and adjacent aisle bays. This buckling would probably have resulted from the inward thrust of these vaults coupled with the rotational movement produced by the tendency of the higher inner aisle vaults to push outwards (see rotational arrows sketched on the section, Fig. 15). The chapel wall at bay 8 provided the extra strength at this point which allowed the piers at C 8 and F 8 to remain solid for six centuries after the completion of the choir: we suggest that the absence of such support in bay 7 was a critical factor leading to the collapse of 1284.²⁴

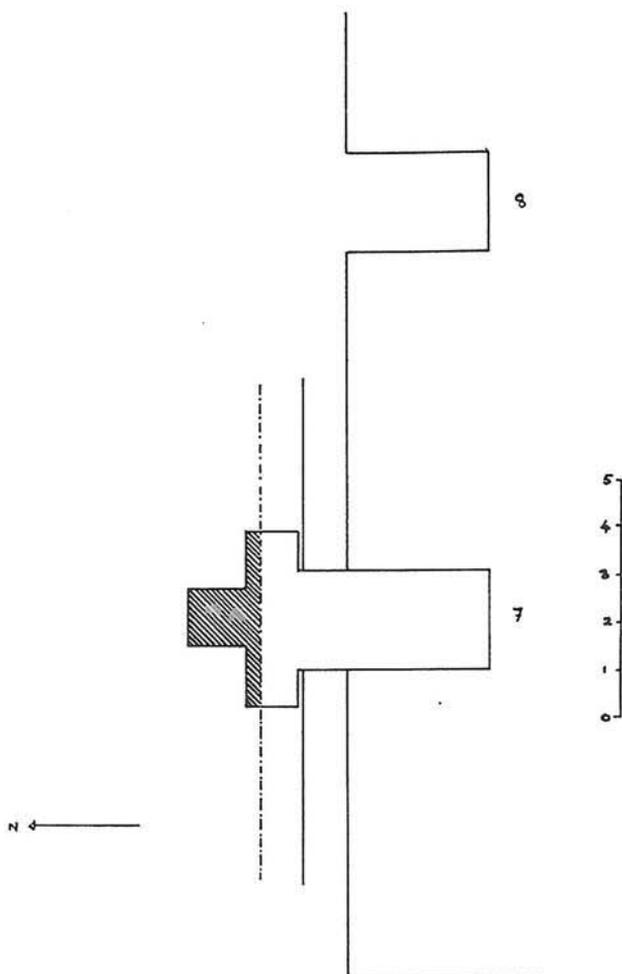
FIGURE 16. Section of outer flying buttress upright at G 7 (cross-hatching indicates porte-à-faux).

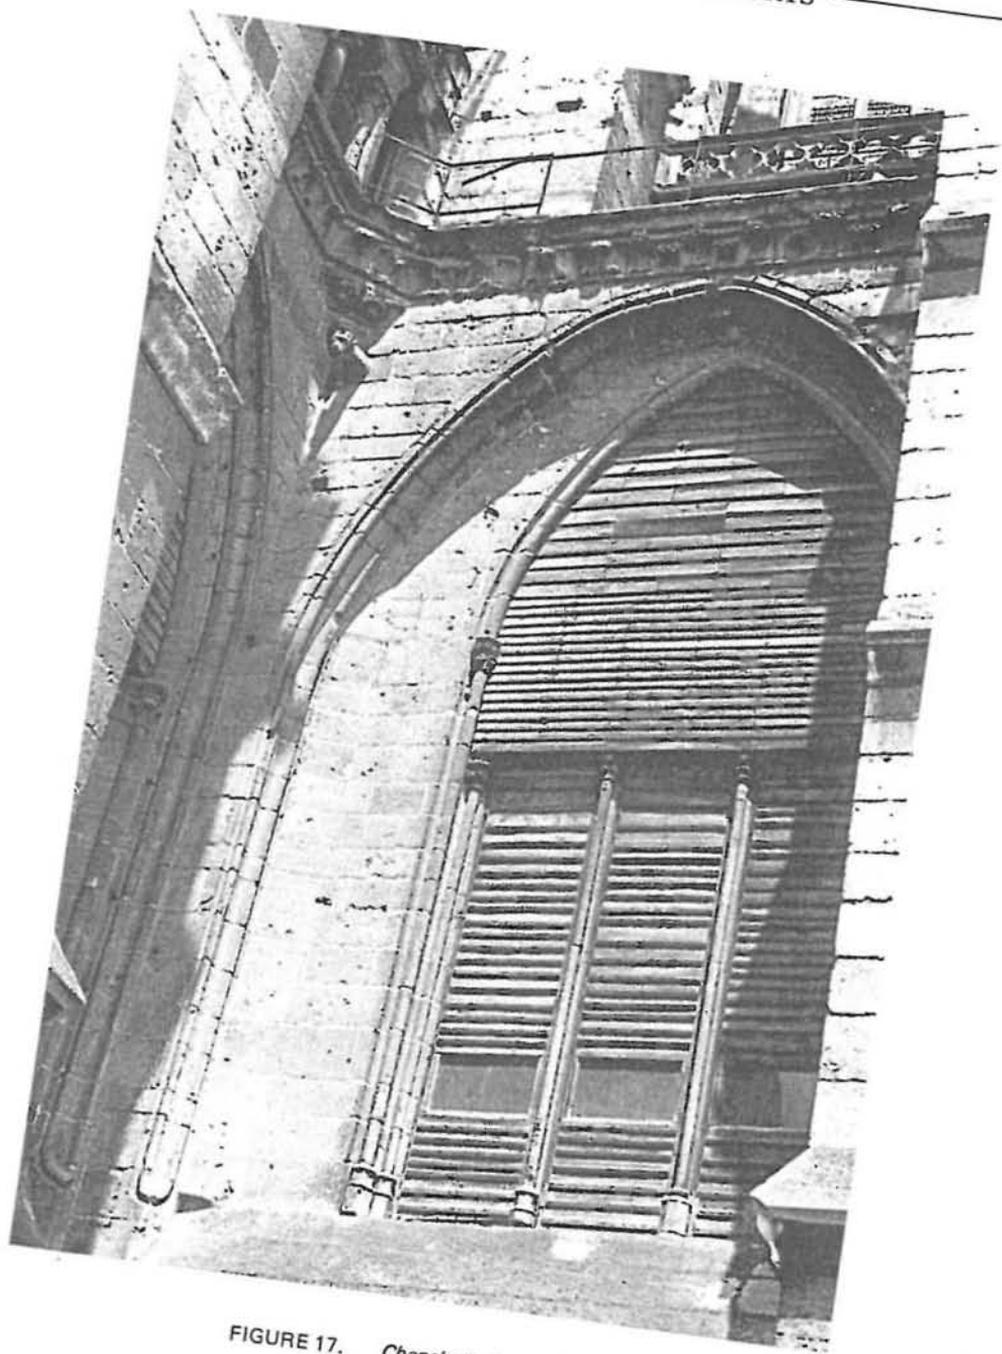
buttress above. The thin voussoir stones of the window have failed, several stones at the crown of the arch have broken, and the geometry of the arch has been severely distorted. It was found necessary in the campaigns of repair immediately following the collapse to insert a narrow strip of masonry to eliminate the overhang.³⁰

FIGURE 17. *Chapel window at G 6-7.*
