## Studies on the structure of Gothic Cathedrals

Pere Roca

**ABSTRACT:** The study of three Gothic Cathedrals is presented with a discussion on the results obtained with regard to their structural features and present condition. The paper focuses on the significant difficulties that the analysts may encounter in the attempt of evaluating historical structures. These difficulties stem from the importance of historical facts (historical genesis, construction process, and possible natural or anthropic actions affecting the construction throughout its life time) and the need to integrate them in the analysis. The case studies of Tarazona, Barcelona and Mallorca Cathedrals are presented. Particular attention is given to Mallorca Cathedral because of the uniqueness and audacity of its structural design and because of the challenges that the analyst must face to conclude about its actual condition and long-term stability.

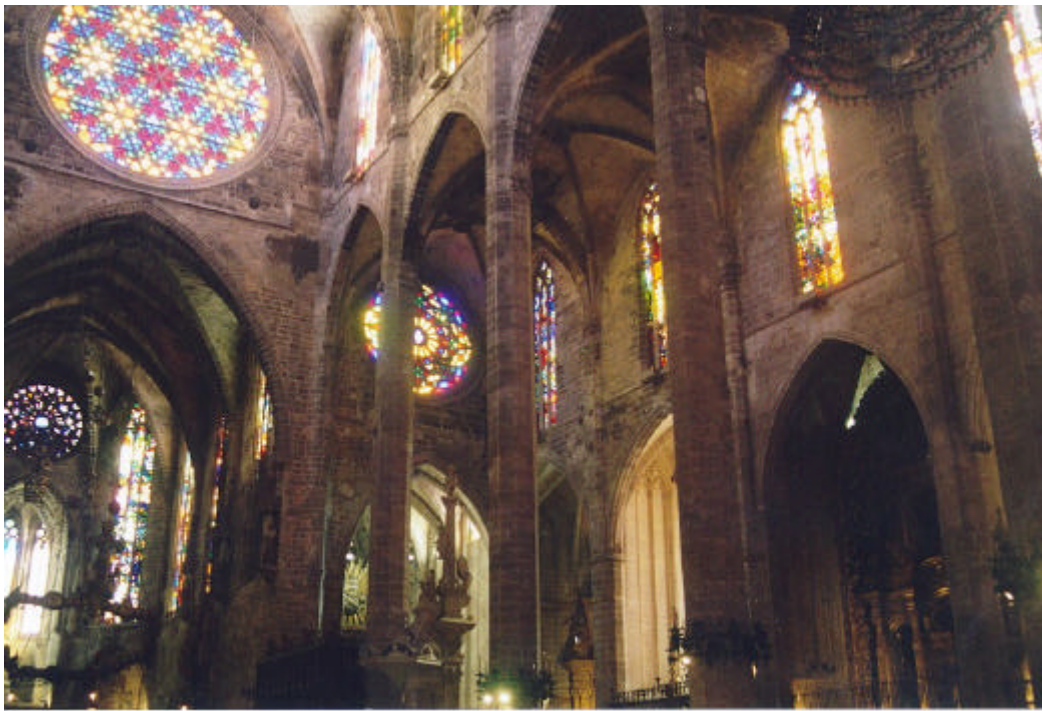
Figure 1: Nave of Mallorca Cathedral

Mallorca Cathedral, described in section 6, constitutes a prominent example of the previous ideas. The central nave, 44 m high at the vault keystone and having 17.8 m of span, is sustained on piers with a diameter of 1.6 or 1.7 m (Fig. 1), characterised by an slenderness (defined as ratio between the free height to the diameter) of 14.1. These proportions would seem audacious in a modern reinforced concrete column; nevertheless, they correspond to a masonry construction, that is to say, to a construction composed

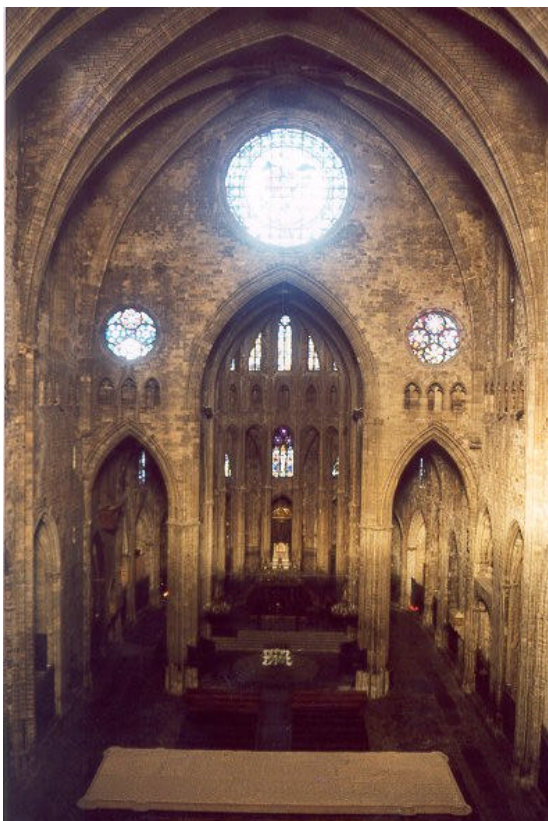
Figure 2: Nave of Girona Cathedral

It is remarkable that, in relation to the construction of the unique nave of Girona Cathedral (Fig. 2), some experts of the time, invited by the Chapter in the year 1416, agreed to consider that the construction of a cross-vault with a span of more than 23 m was possible and appropriate; they agreed to validate the capacity of the existing walls and foundations to receive the weight and the lateral thrust of the large vaults of the unique nave. However, some of the experts pointed out that the stability might not be granted in the event of an earthquake or hurricane wind. Although, as mentioned, no rationale or technical arguments were exhibited to sustain the opinions of the experts, yet it is very patent that they had the knowledge that allowed them to conclude on delicate structural facts. (A more detailed description of the discussions happened during the meeting in 1416 can be found in Huerta 1998).

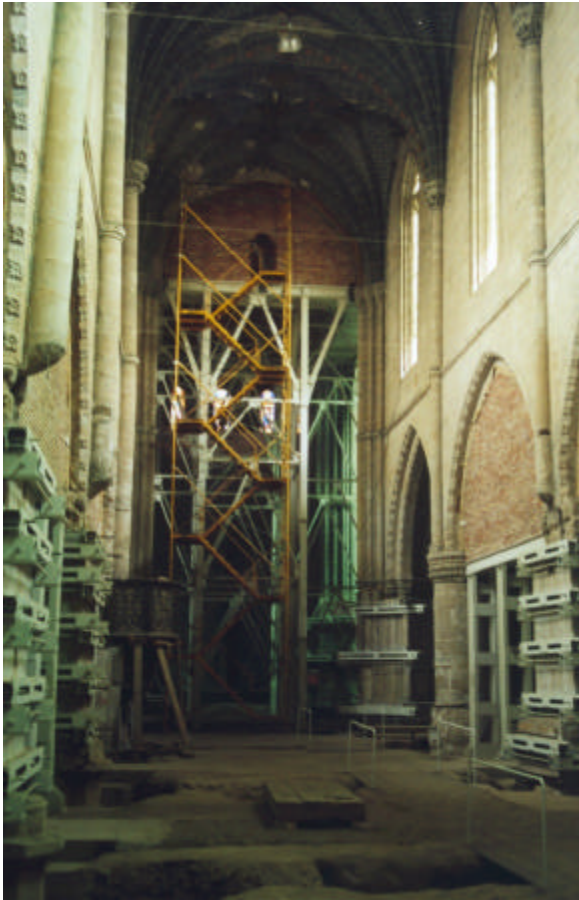
Figure 3: Tarazona Cathedral. Cimborio and clerestory arches propped on steel frame and masonry diaphragms; piers encircled with timber and steel confinement.

Due to the material and structural deterioration of the building, a large part of it, including the cimborio and the clerestory walls, was propped on steel frames some decades ago, and the cathedral closed to public for years (Figs 3, 4). A restoration programme, including repair and strengthening operations, is now being carried out with the aim to eliminate the propping system.

Different events have contributed to deteriorate the construction. First, chemical attack has produced significant degradation of the stone of the piers to the extent of making it advisable to confine some of them with timber and steel auxiliary elements.

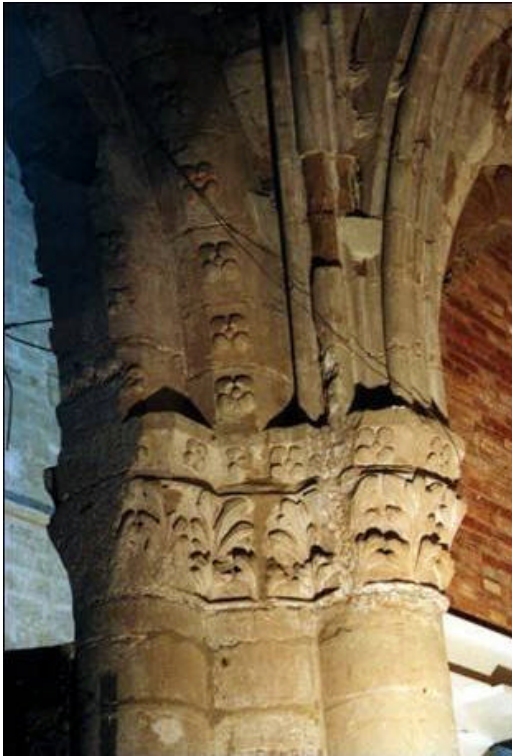
Figure 5: Tarazona Cathedral. Lesions related to excessive compression at the springings of the aisle arches.

Today, the limestone original piers and arches of the nave (Fig. 4) show damage of mechanical origin such as cracking and crushed material in some points. The main lesions observed in the nave are: (1) cracks at about mid-span of the flying arches; (2) degradation of the stone in the base of the piers; (3) in some bays, cracks developed in the transverse ribs of the arches, close to the inner springings; (4) vertical cracks separating the masonry backing of the aisle vaults from the walls; (5) a large crack at the key of the main transverse arches.; (6) vertical cracks separating the backing of the nave vaults from the clerestory walls; and (7) damage in the nervatures due to excessive compression at the inner springings of the aisles (Fig. 5).

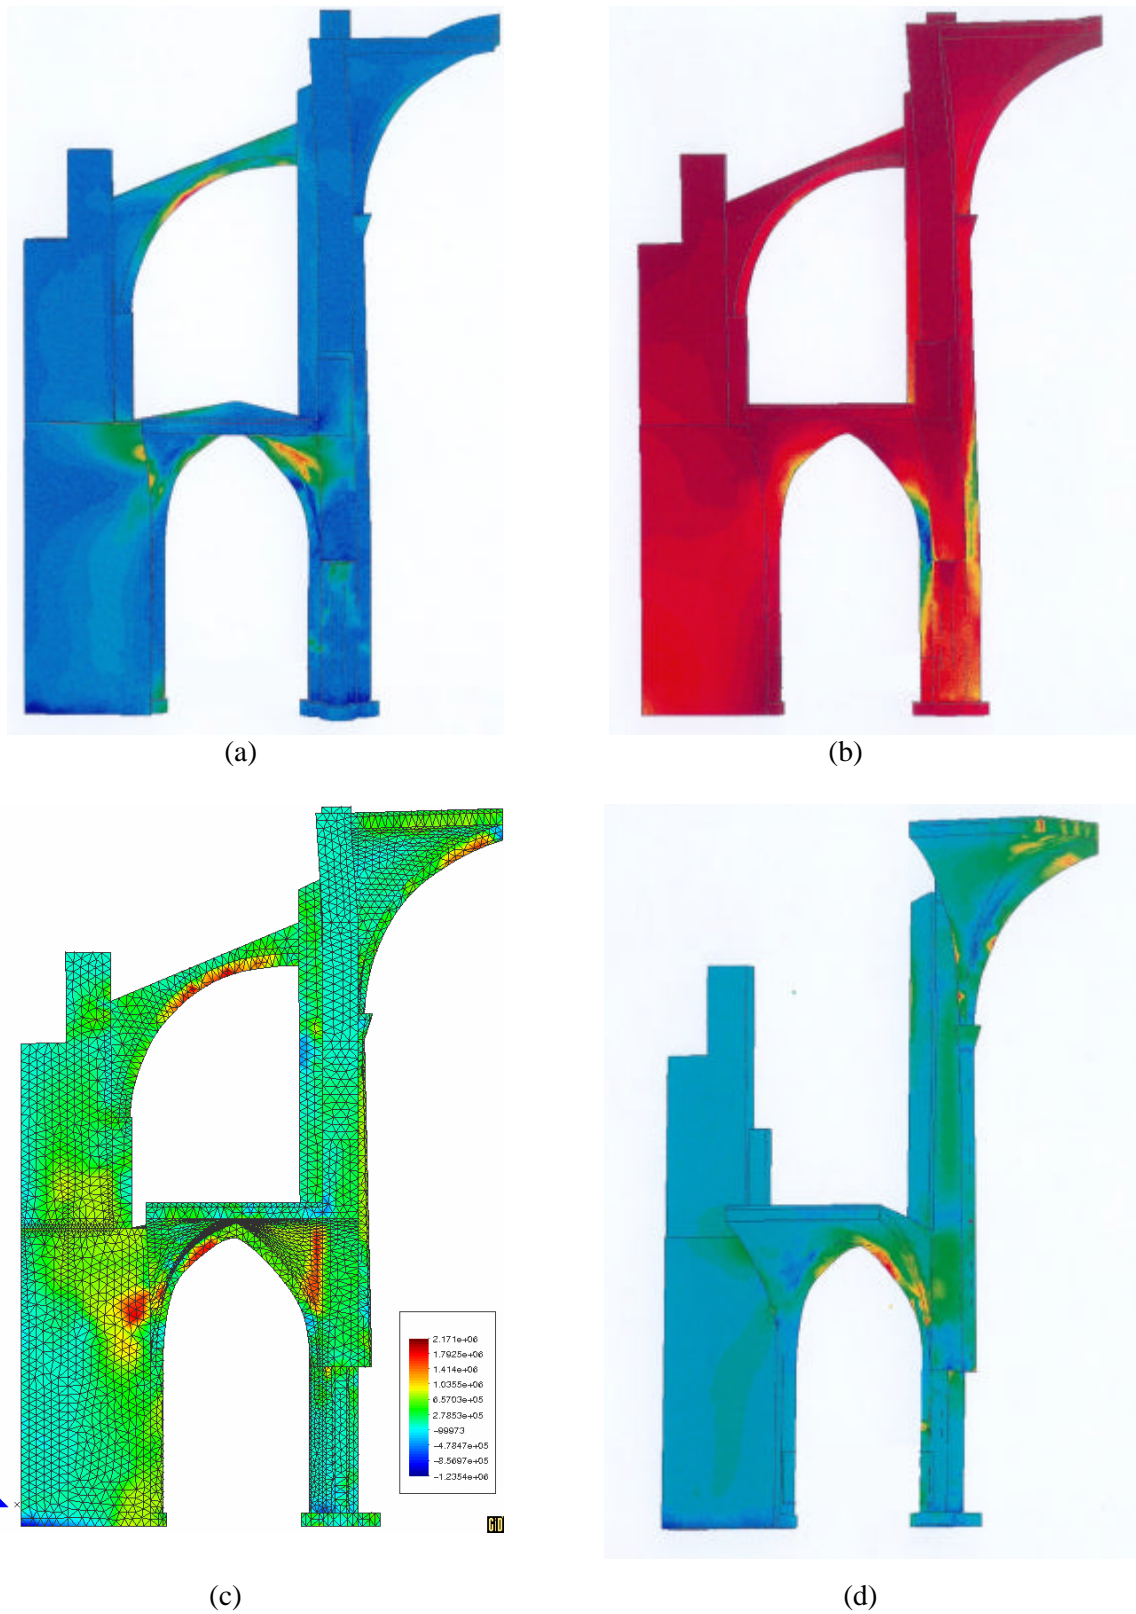
Figure 6: Numerical model prepared for the analysis of the nave of Tarazona Cathedral by means of FEM-Continuous damage model. Distribution of maximum tension stresses (a) and maximum compression stresses (b) in the initial configuration. Distribution of tension stresses after the reduction of the section of the pier (c) and once the flying arch is removed (d).

The analysis carried out by the numerical techniques allows a correlation between the effects introduced by the historical alterations and existing lesions (Fig. 6). Thus, cracks (1), (5), (7) seem associated to the initial condition; reducing the section of the piers produced a certain extension of the zones affected by excessive tension or compression stresses; and removing the flying arches may have motivated cracks (3) and (5).

Remarkably, the analysis predicts a rather fair, almost deficient, condition of equilibrium even for the initial, intact configuration. According to GMF, failure would occur at 110% the dead loading, while the FEM damage model predicts the failure for 130% the dead load. Given the existing damage and given the very small marginal capacity predicted, the need to prop the construction until the implementation of some strengthening measures seems justified. The effects of anthropic actions and other historical causes may have been so severe because of the initial precarious condition and the resulting sensitivity to any possible alteration.

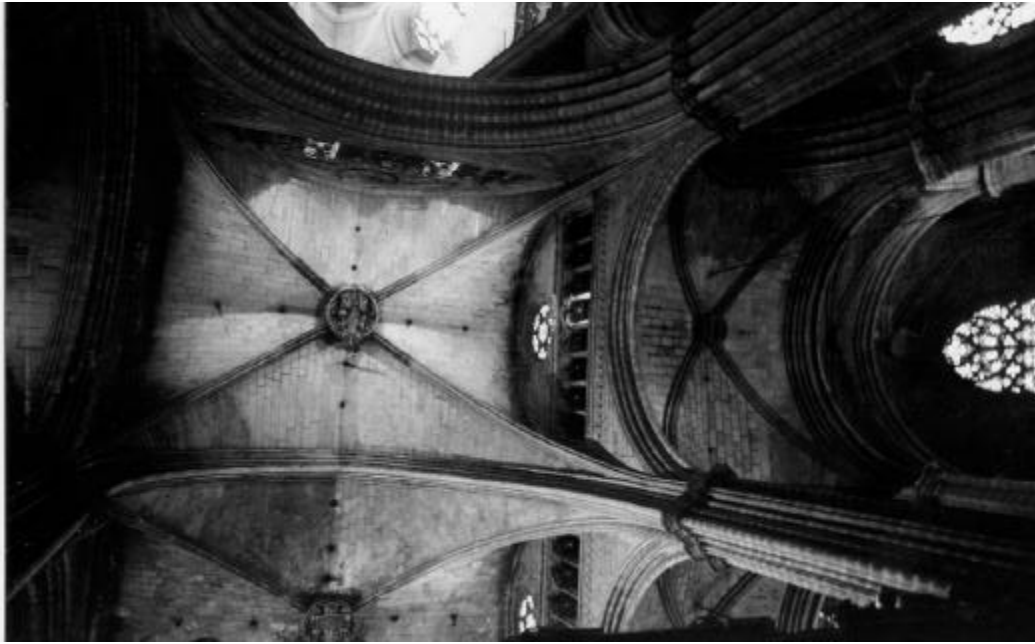
Figure 7: Nave of Barcelona Cathedral

Construction of the naves of Barcelona Cathedral (Fig. 7) was begun in 1298 and lasted for more than a century. As usual, the choir was constructed first, being finished in 1327, while the construction of the entire nave continued until 1417. In 1422 work stopped, leaving the cimborio unfinished and a provisional wall closure as a façade. The building has a three-nave plan (the nave and two aisles) although, as a consequence of its particular design, it appears to enclose two additional aisles. This particular effect is caused by the inclusion of the imposing buttresses in the interior space between the side chapels. The nave spans 12.80 m and has a maximum high of 25.6 m. The span of the side aisles is equal to one half the span of the nave. The rise of the vaults at the side aisles, of 20.5 m, begins close to the springings of the central vaults. Thanks to this particular arrangement, the lateral thrust of the central vaults is efficiently carried to the buttress by the lateral vaults so that actual flying arches are in fact not needed. The overall system shows –as demonstrated by the analyses– large robustness thanks to the imposing buttresses (with a base of 7.4 m of length equal to 58% the maximum span) and the optimal structural arrangement. The existing flying arches are but draining devices with no structural role.

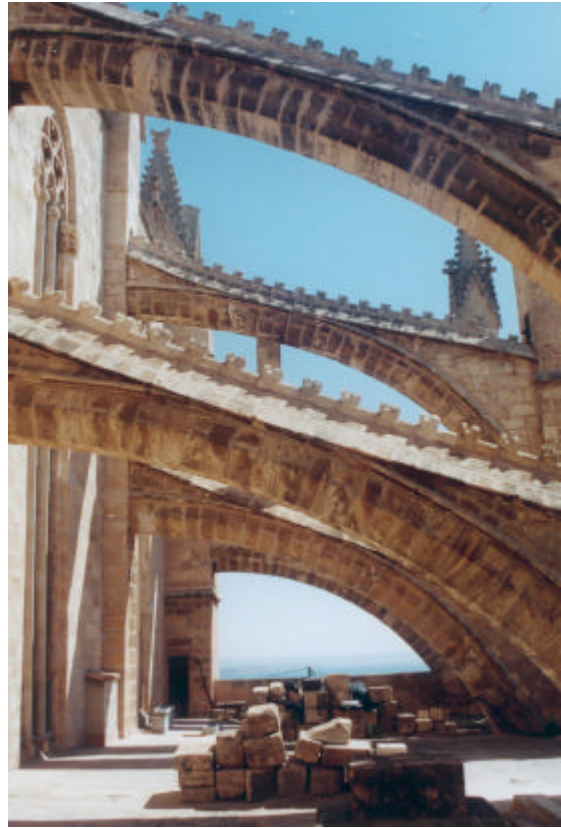
Figure 10: Double battery of flying arches

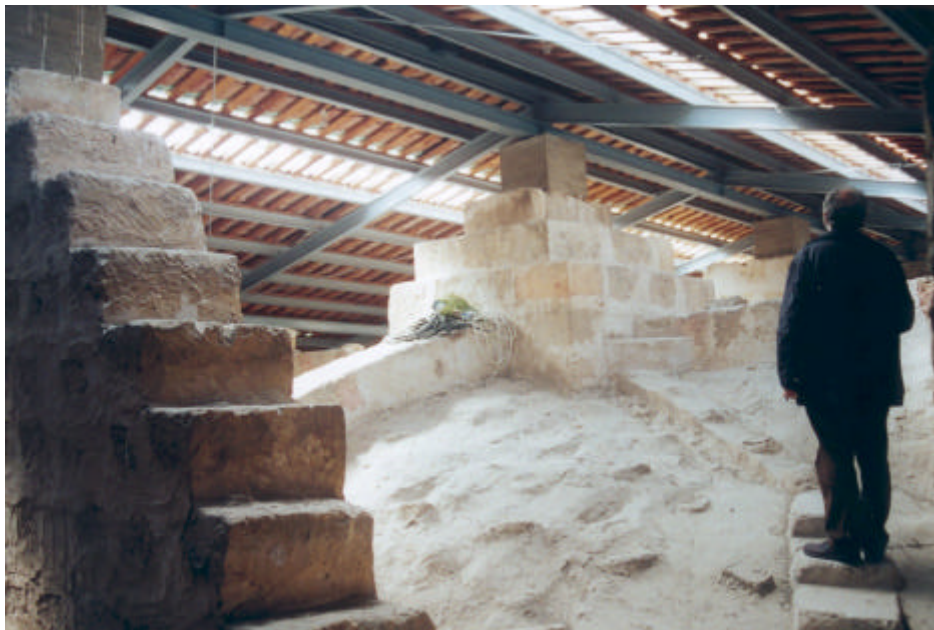
Figure 11: Masonry dead weights placed on top of the arches and vaults of the nave

According to Rubió, attaining stability in the real construction should have required the inclusion of artifices such as the dead loads (in the form of masonry pyramids) placed over the vaults and main arches (Fig. 11); at least, his calculation showed that such contribution was required to obtain the equilibrium solution.

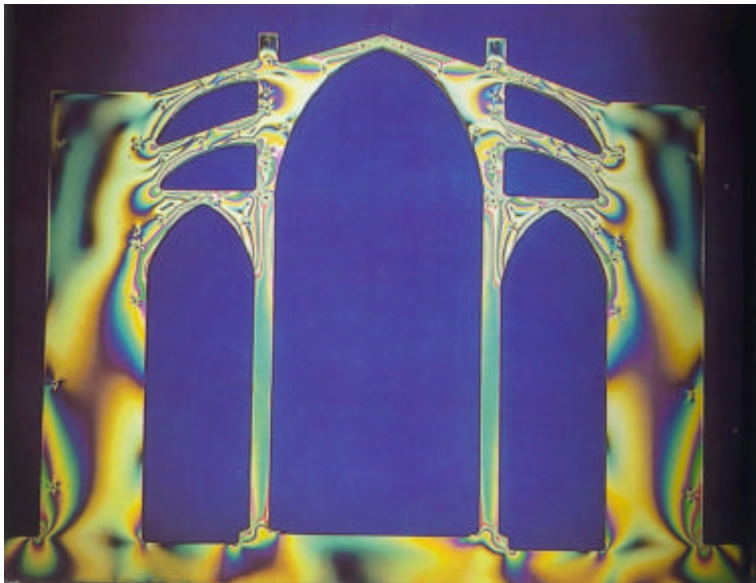
Figure 14: Photo-elastic modelling of the nave of Mallorca Cathedral by Mark (1984)

The pioneering studies on the structure of Gothic Cathedrals carried out in the 70's by Robert Mark (1982) included the analysis by photo-elastic modelling of many emblematic Gothic constructions. Given its structural interest, the case of Mallorca Cathedral was also considered and analysed using the same technique.

The analysis permitted to draw interesting conclusions about its structural features and response subject to gravity loading and wind. Interestingly, some of the conclusions reached by Mark are not in agreement with those drawn by Rubió. According to Mark (1982), the photo-elastic study predicts a very uniform state of compression in the piers under dead-weight, indicating that the amount of bending is so negligible as to be unique among the many Gothic churches discussed by the author.
